# SAGAMORE HILL HOME OF THEODORE ROOSEVELT

Sagamore Hill National Historic Site  
Oyster Bay, New York

Historic Structure Report

**SAGAMORE HILL  
HOME OF THEODORE ROOSEVELT  
HISTORIC STRUCTURE REPORT**

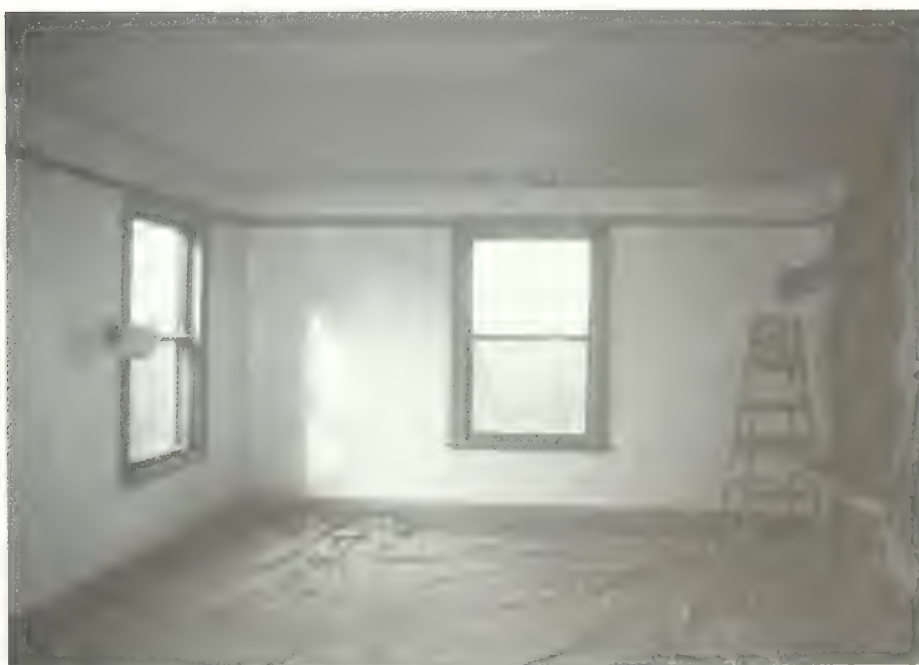
**Gate Room: Before Restoration**

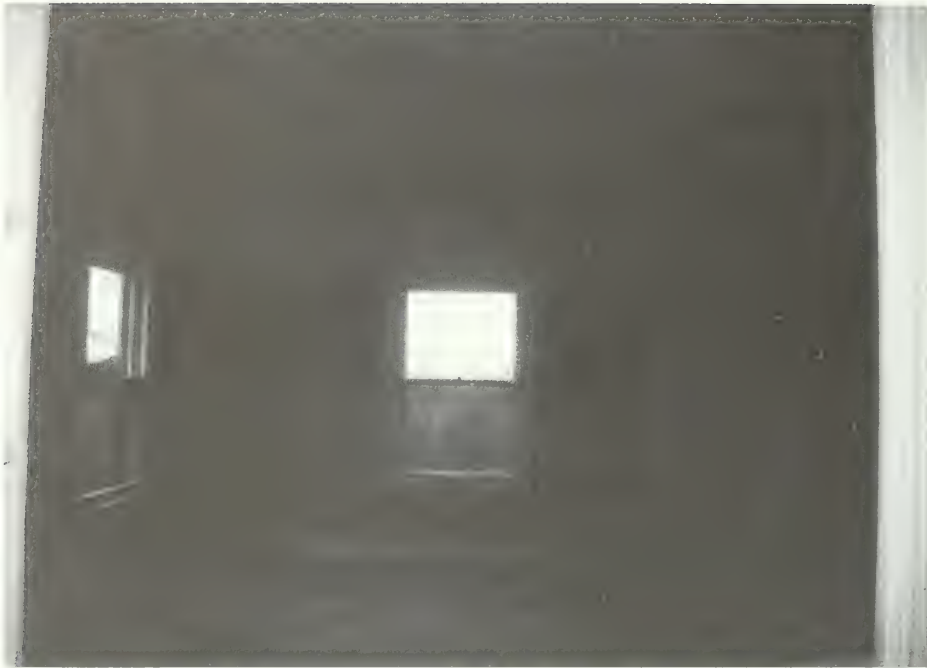
**Gate Room: During Restoration (picture molding lowered, wallpaper removed).**

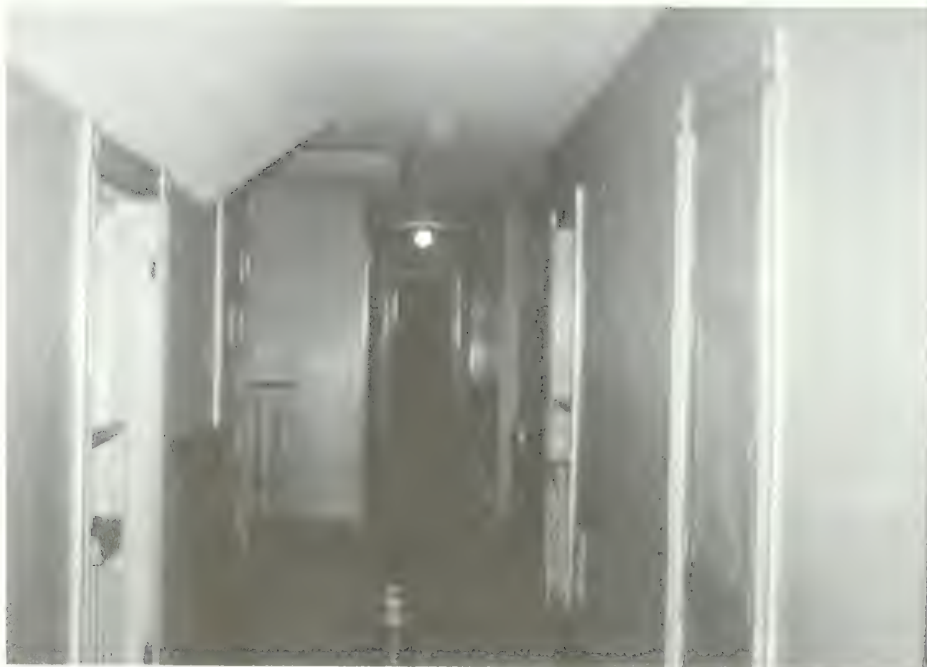
**Gate Room: After Restoration**

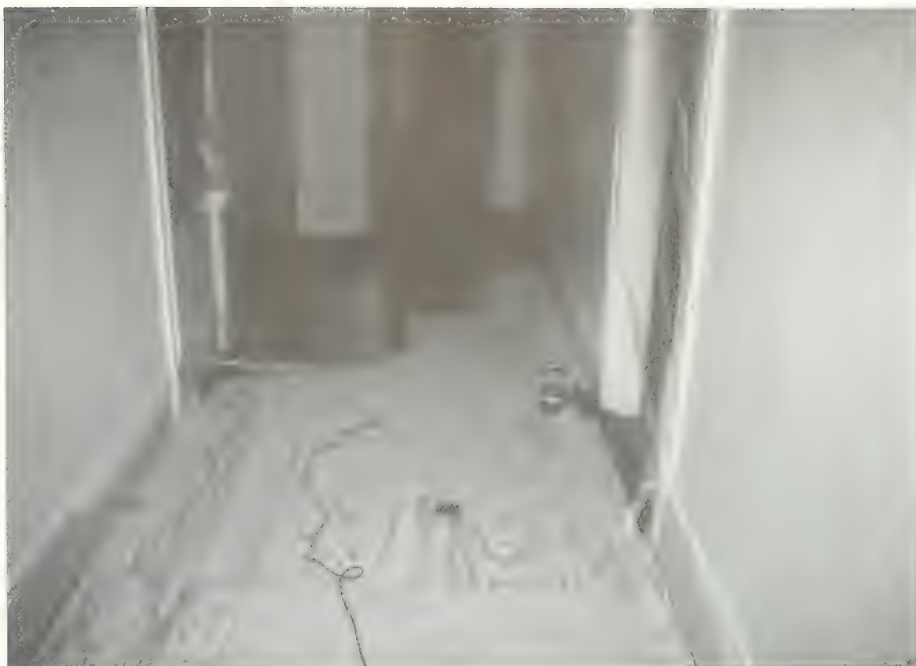
**Third Floor Hall: Before Restoration**

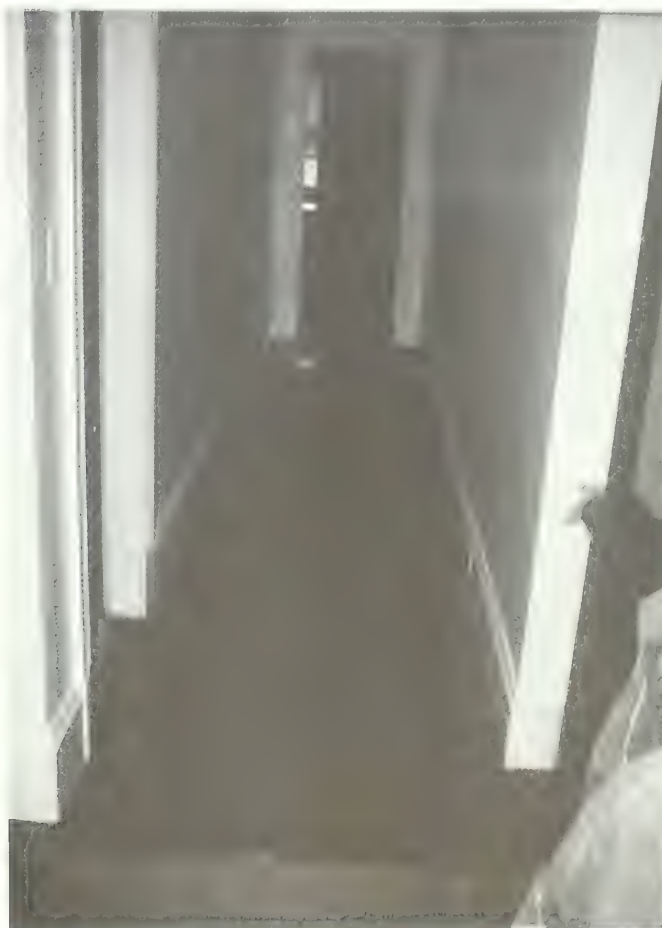
**Third Floor Hall: Plywood Installed On Floor**

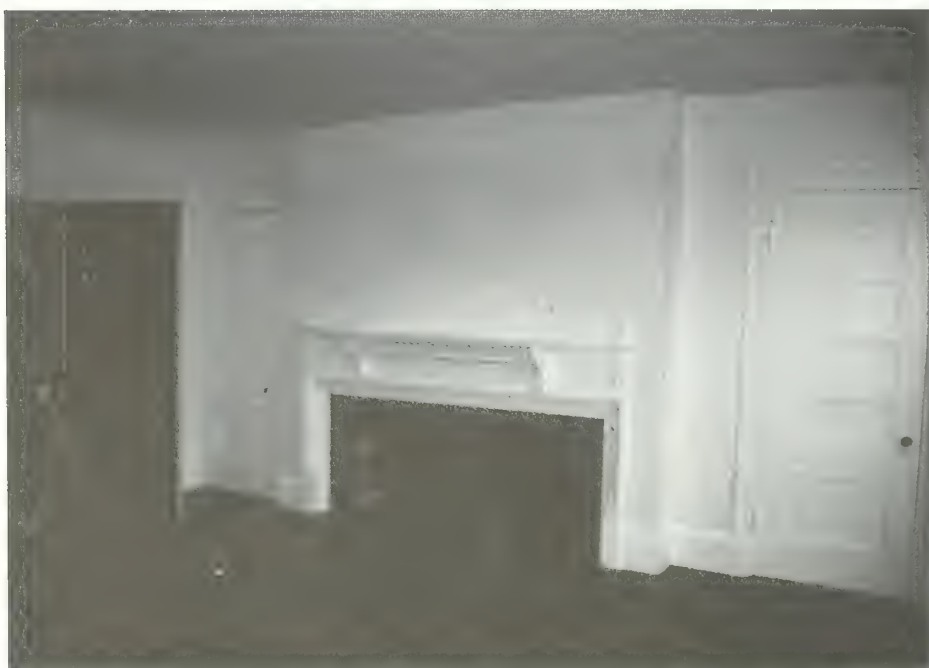
**South Bedroom: Before Restoration**

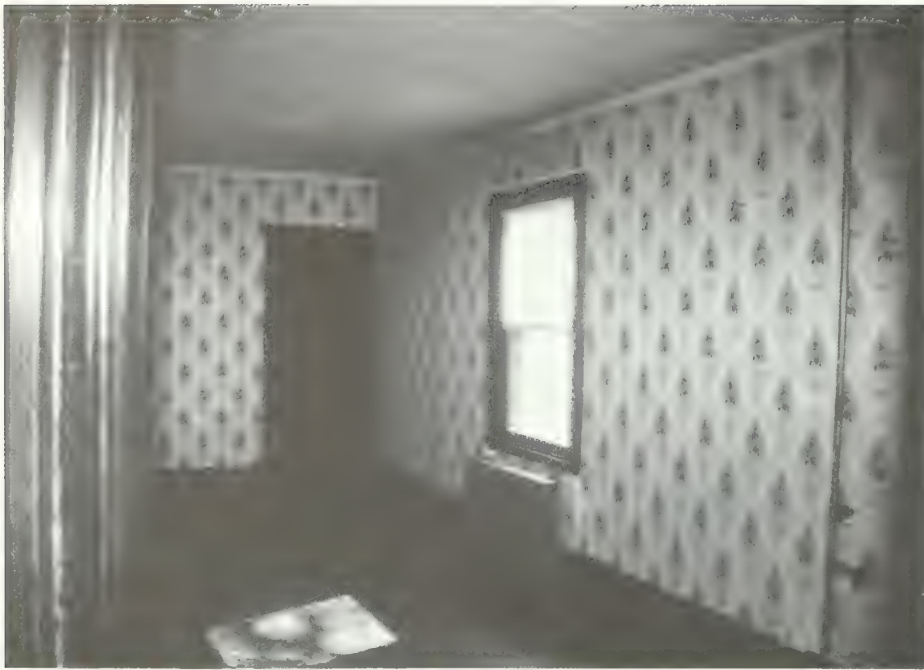
**Alice's Room: Before Restoration**

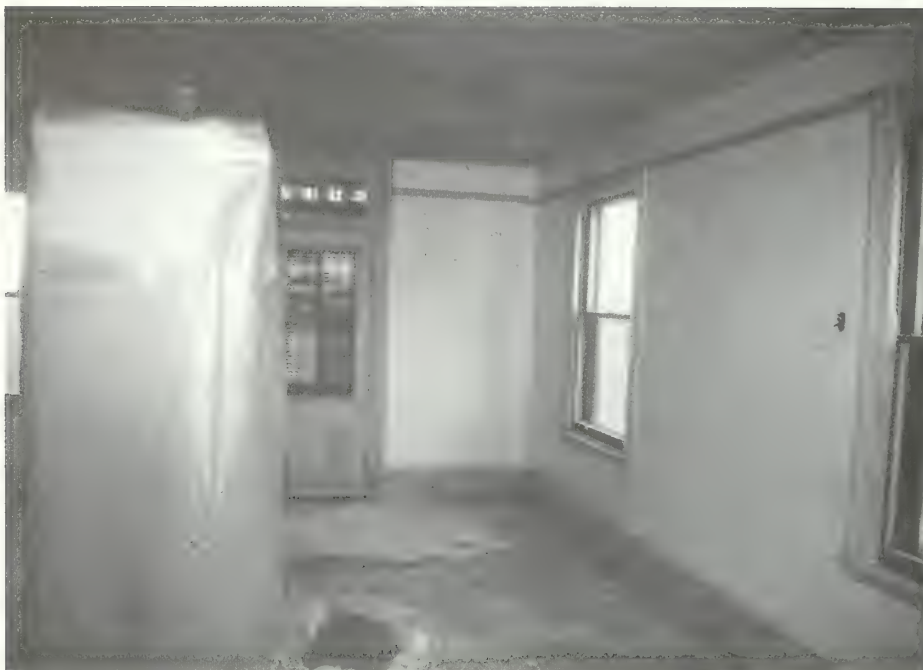
**Mother's Room: During Restoration (wallpaper removed,  
picture molding lowered).**

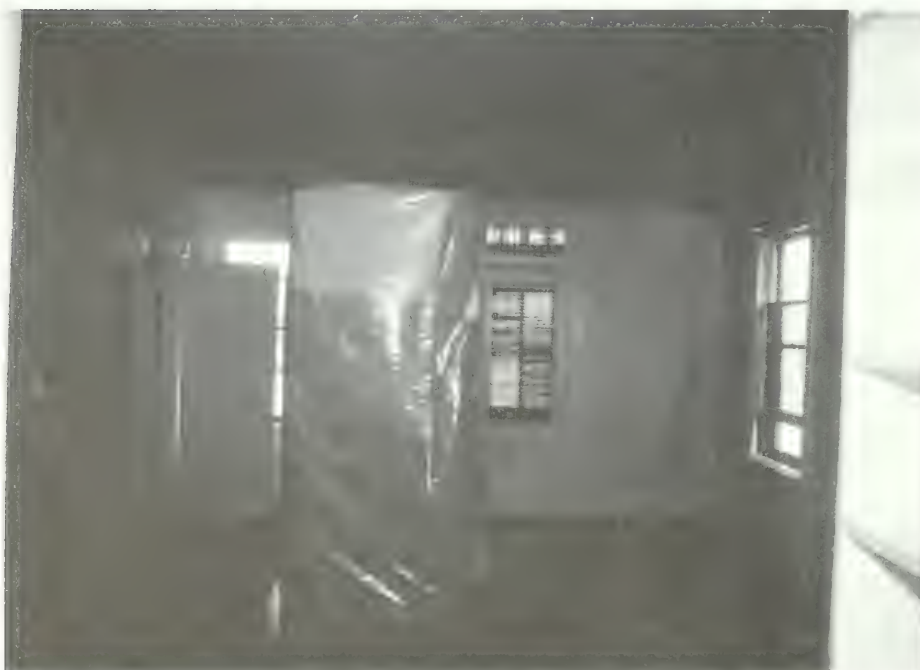
**Mother's Room: After Restoration**

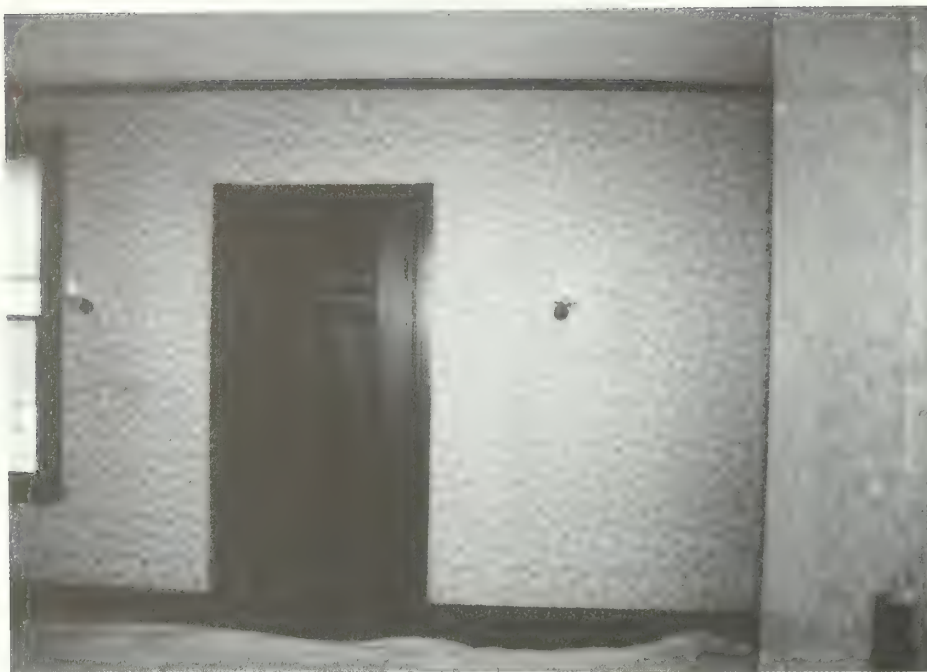
**Nursery: Before Restoration**

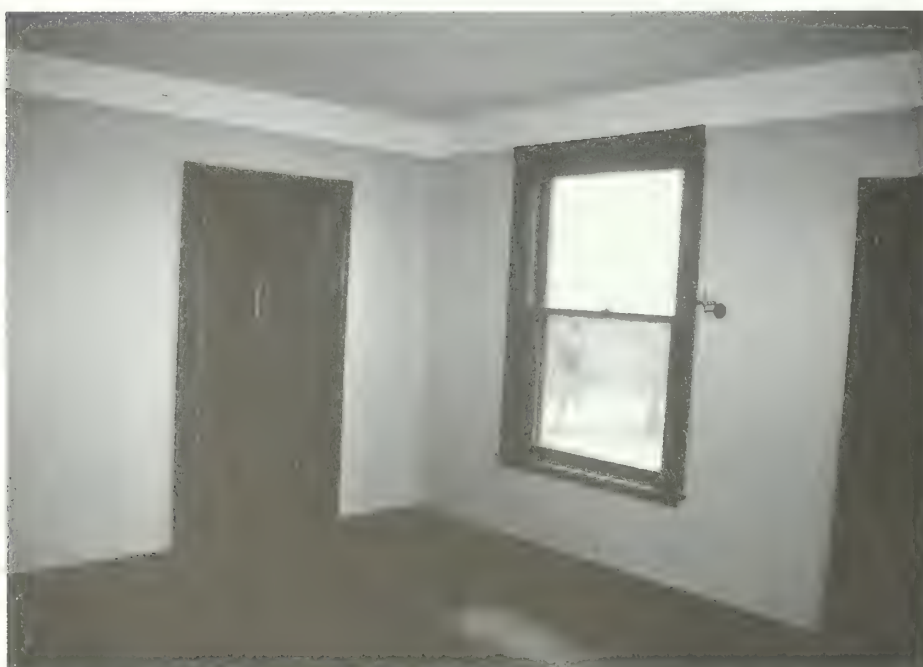
**Nursery: After Restoration**

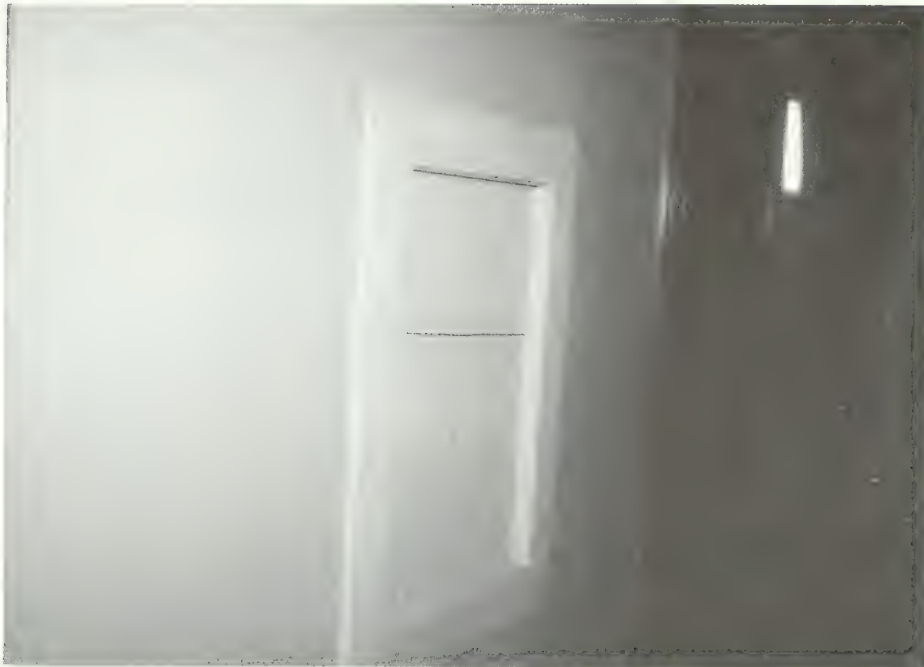
**Typical Firebox Location in Hallway: Before Restoration**

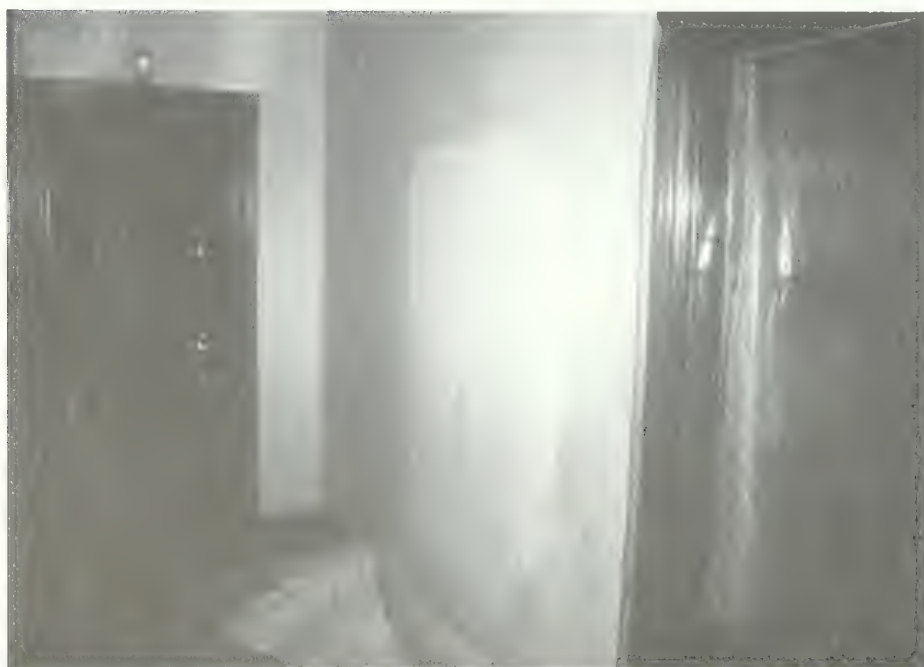
**Typical Firebox Location After Removal and Replastering**
